#### Superior Barrel and Drum Site Emergency Removal Action September through December 2013

R2 - 000313

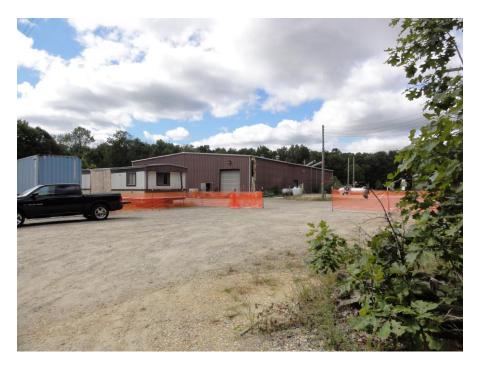
Photo 1: September 2013, the Environmental Protection Agency (EPA) erected a fence along the public roadway of the Superior Barrel and Drum Site (Site) to restrict access.

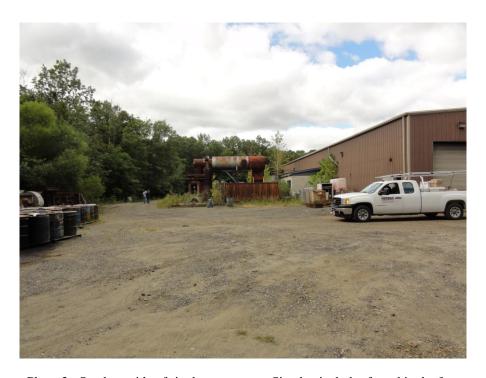
Photo 2: Southern side of single structure on Site that includes funnel in the foreground and drum storage along the tree-line on the left.

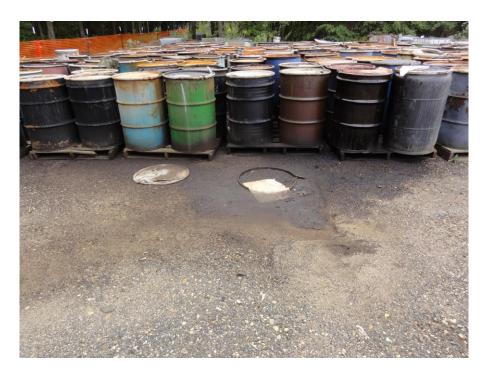
Photo 3: Out-door drum storage area at the Site with the evident staining on the ground surface.

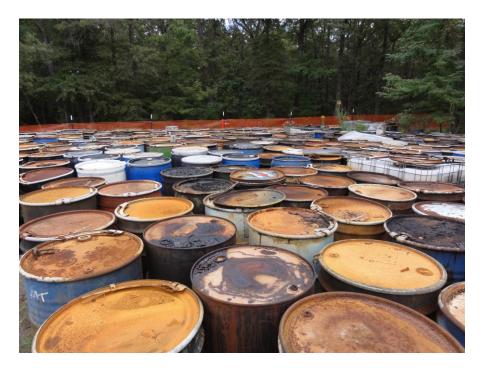
Photo 4: Additional view of the abandoned drums at the Site.

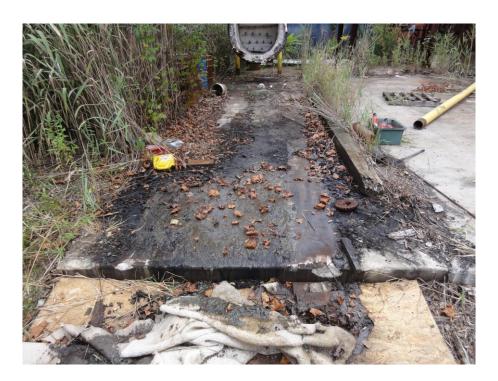
Photo 5: Unknown material spilled and stained concrete pad at the Site.

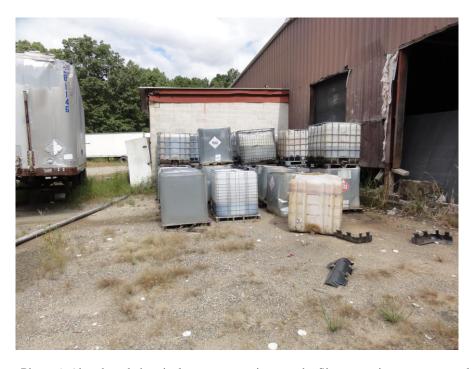
Photo 6: Abandoned chemical storage containers at the Site, many in poor structural condition.

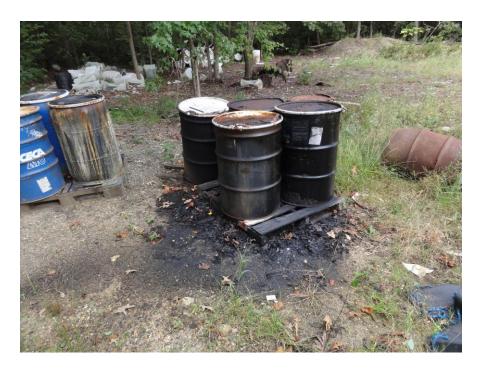
Photo 7: Abandoned damaged drums and stained soil around it.

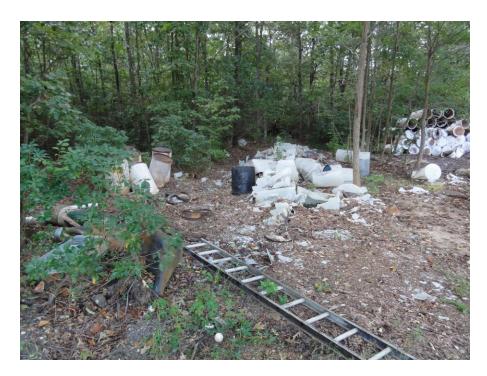
Photo 8: Additional view of the abandoned drums at the rear of the Site.

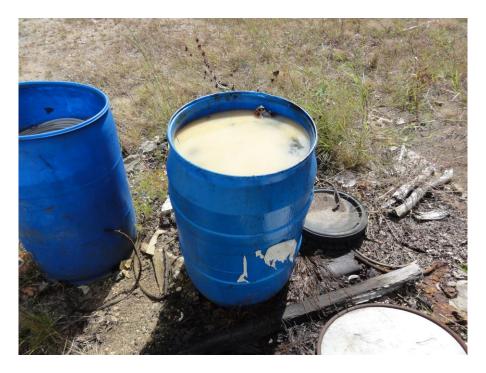
Photo 9: Unsealed containers holding chemicals mixed with rainwater.

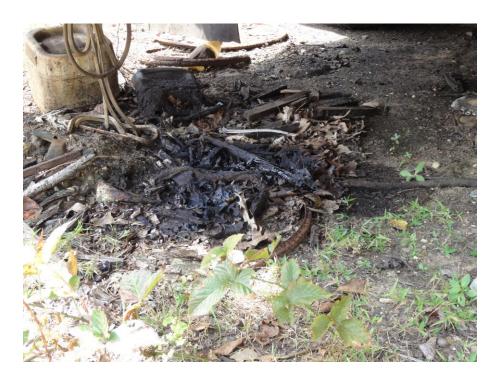
Photo 10: Stained soil and vegetation near damaged drums at the Site.

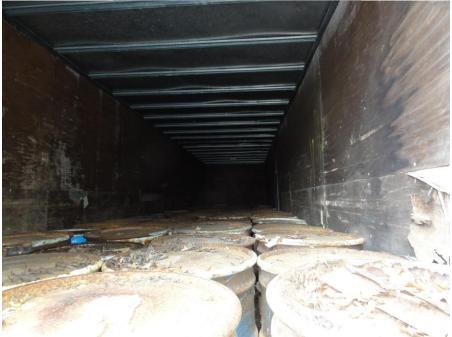
Photo 11: A number of truck trailers were found on-site that contained drums in poor structural condition.

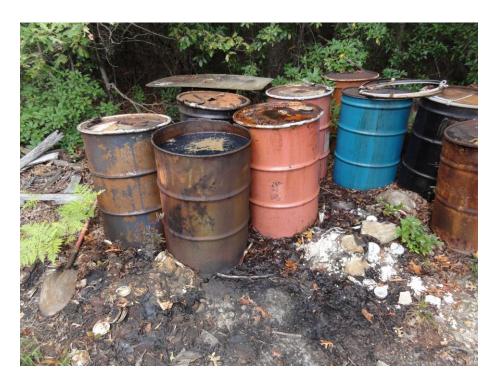
Photo 12: Leaking, unsealed and damaged drums at the Site.

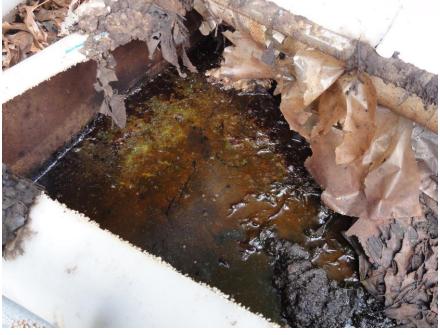
Photo 13: Unsealed containers exposing chemicals.

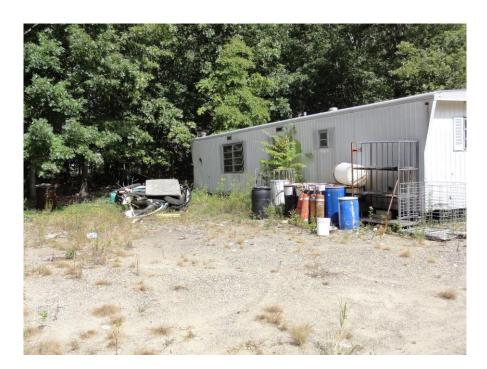
Photo 14: Abandoned drums and the gas cylinders located near former office trailer.

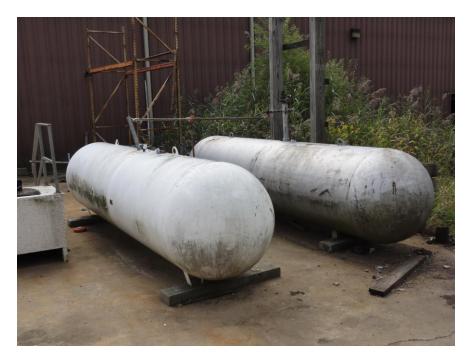
Photo 15: Above-ground Storage Tanks (AST) at the Site.

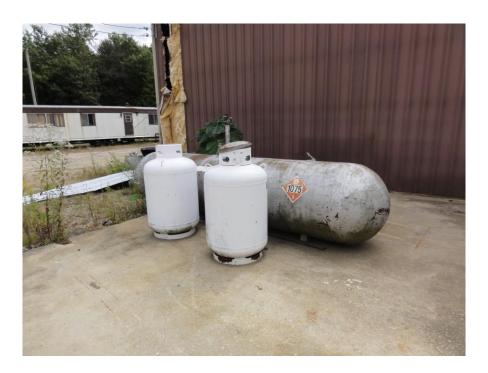
Photo 16: Additional AST at the Site.

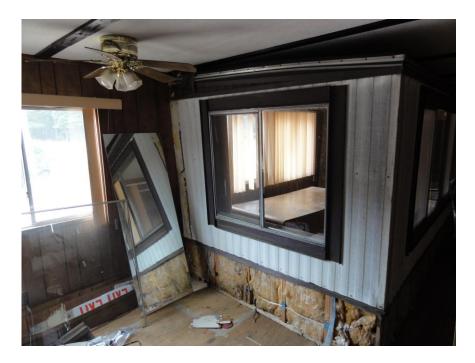
Photo 17: Interiors of the trailer located on-Site.

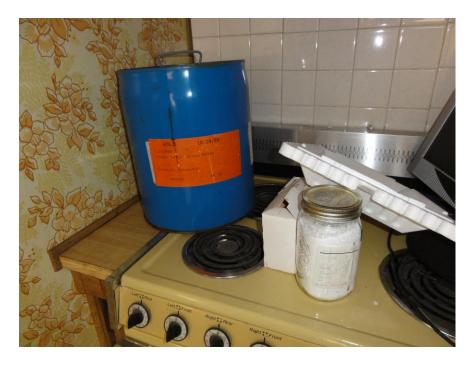
Photo 18: Inappropriate chemical storage inside the trailer.

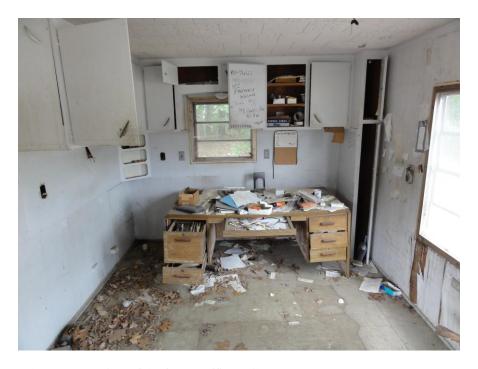
Photo 19: Interiors of the former office trailer.

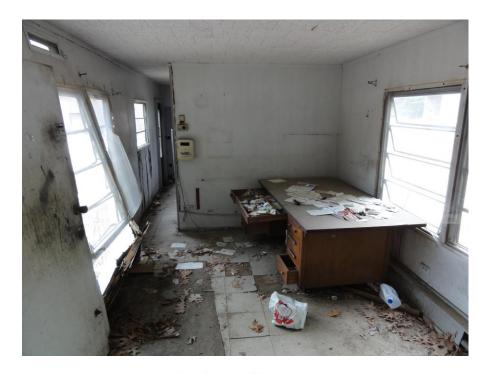
Photo 20: Additional view of the former office trailer.

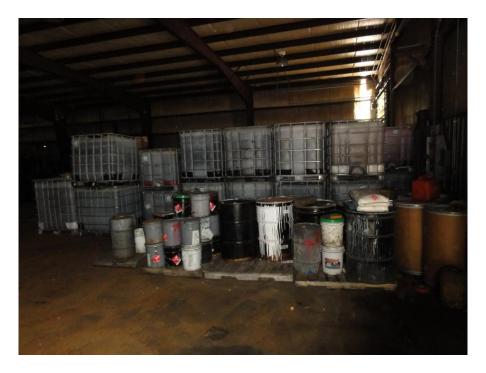
Photo 21: Steel metal warehouse structure used to store various containers.

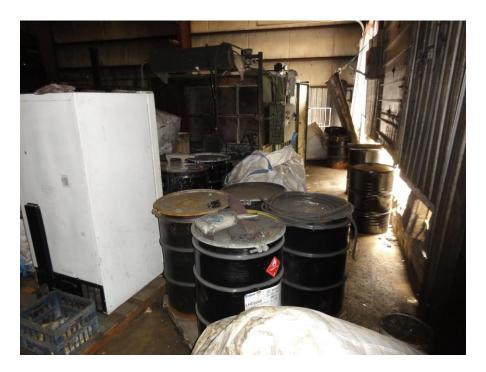
Photo 22: Drums and miscellaneous tools and equipment staged hazardous conditions in the interior of the Site structure.

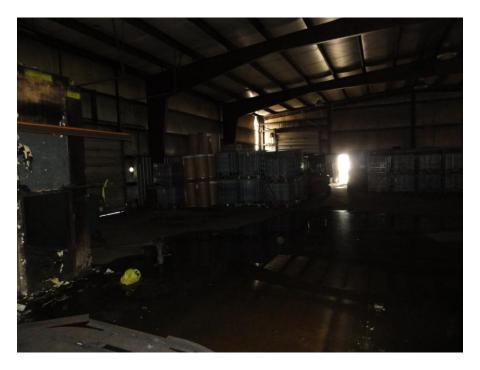
Photo 23: Disrepaired of the Site structure is evident with the pooling of rainwater inside the warehouse.

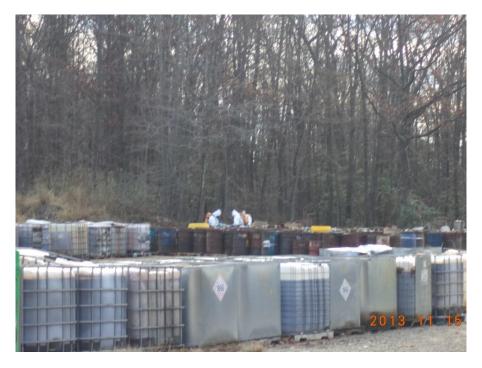
Photo 24: EPA contractors collecting samples from drums located on the Site.

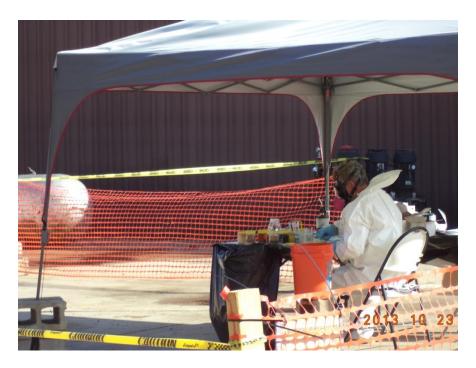
Photo 25: On-site material testing conducted by EPA contractors.

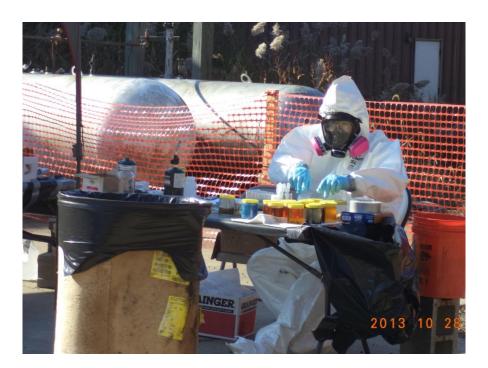
Photo 26: On-site material testing conducted by EPA contractors.

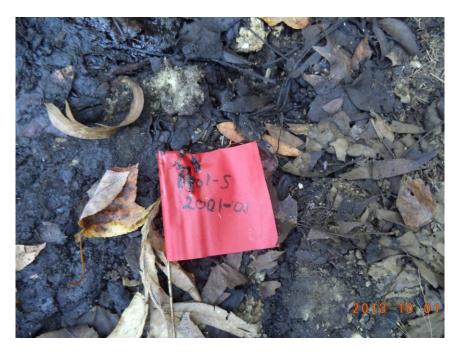
Photo 27: One of the soil sampling locations from October 2013 sampling event conducted by EPA.

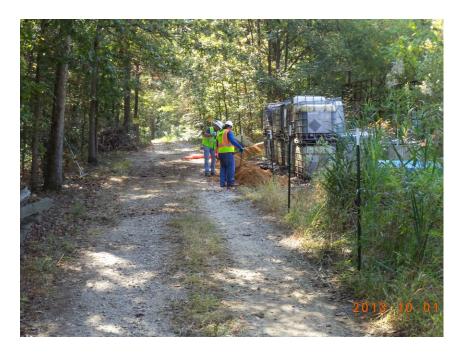
Photo 28: EPA contractors constructing engineering controls (i.e. berm) to prevent off-site migration of materials.
